Three-dimensional laser scanning in aircraft surfaces

Universidad de los Andes

Daniel Páez - Luis Miranda

Three-dimensional laser scanning test in aircraft surfaces

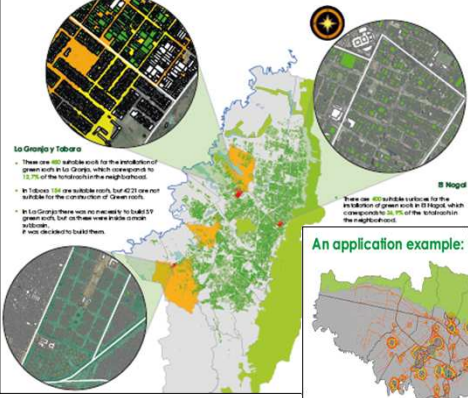
Green roof allocation analysis

- There are 400 available roofs for the installation of green roofs in La Granja, which correspond to 12.7% of the total roof in the neighbourhood.
- In Tabacal 150 are available roofs, but 42% are not suitable for the construction of Green roofs.
- In La Granja there are not available to build 159 green roofs, but in these areas there are small wetlands. It was decided to build them.

There are 420 suitable surfaces for the installation of green roofs in El Bojotí, which corresponds to 21.7% of the total roof in the neighbourhood.

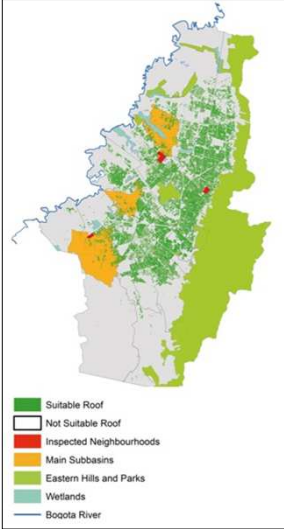
■ Suitable Roof
■ Not Suitable Roof
■ Inspected Neighbourhoods
■ Main Subbasins
■ Eastern Hills and Parks
■ Wetlands
— Bogotá River

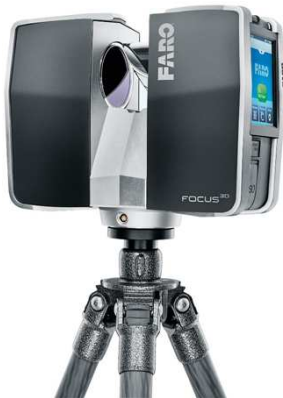
Range error	Focus range	Resolution
±2mm @10m	0.6m a 120m	to 70 Mpxl
Speed of measure		Ranges
122000-976000 pts/seg		305°/360°

General characteristics, Faro laser scanner (FARO, 2013)

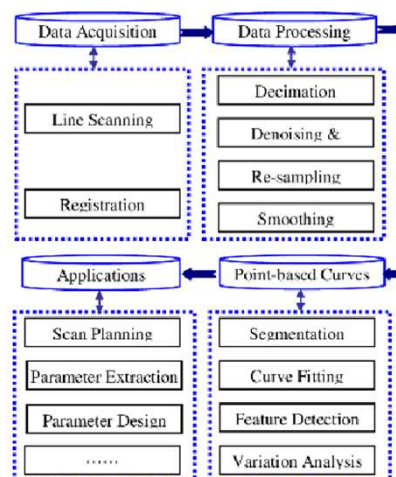
- Identification technics
 - By light intensity

Data pipeline and processing framework (Chen, Du, Jia, & Song, 2010)

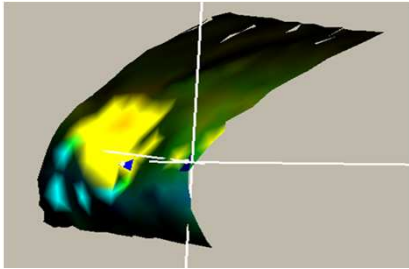
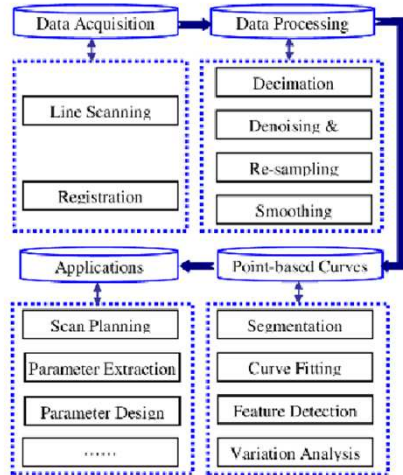
- Identification technics
 - Surface shading based on an imaginary light adjacent to the surface

Data pipeline and processing framework (Chen, Du, Jia, & Song, 2010)

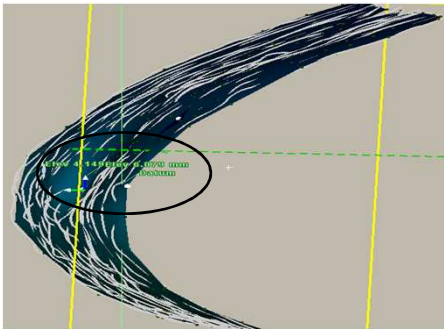
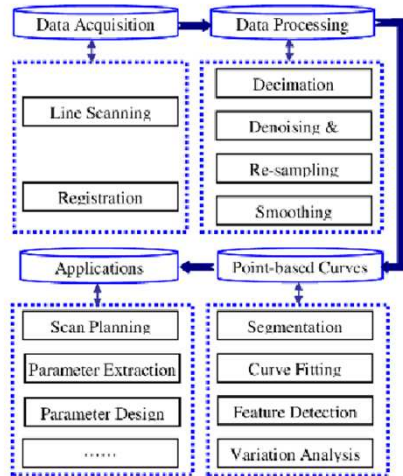
- Mensuration technics
 - By datum and maximum distance

Data pipeline and processing framework (Chen, Du, Jia, & Song, 2010)

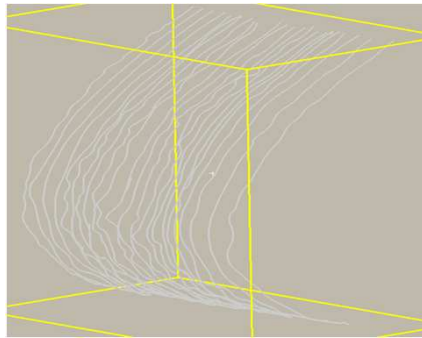
- Mensuration technics
 - Series of cubic splines by slices

Data pipeline and processing framework (Chen, Du, Jia, & Song, 2010)
