FIG e-Working Week, 2021, the Netherlands

WORKING WEEK 2021 20-25 JUNE

Geospatial Analyses of Mining-Induced Land Degradation Sites in Jos South Local Government Area, Plateau State-Nigeria

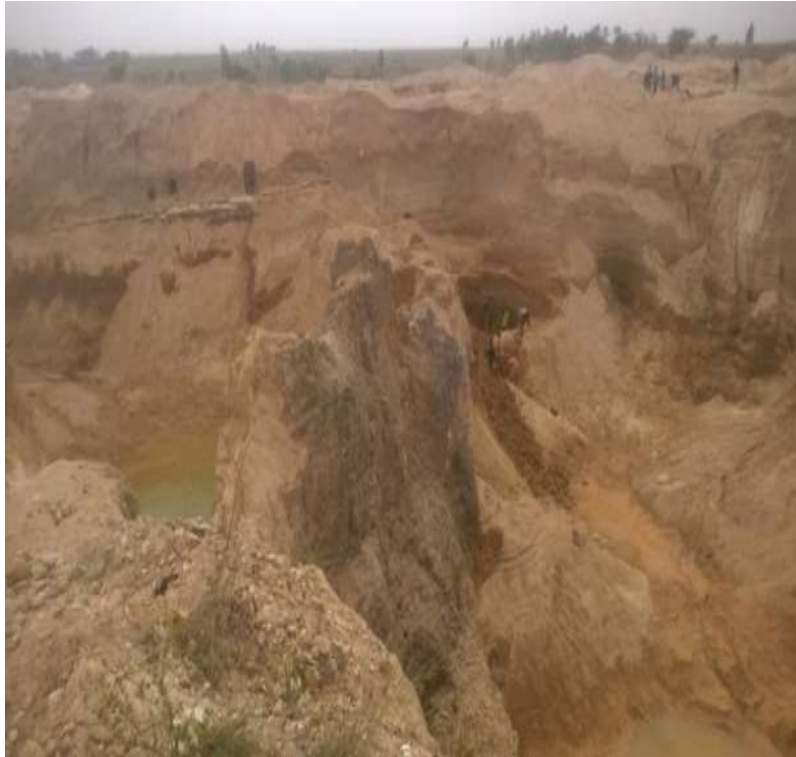
Plate I: Active Mining Site at Kuru Janta Mines (10/11/2015)

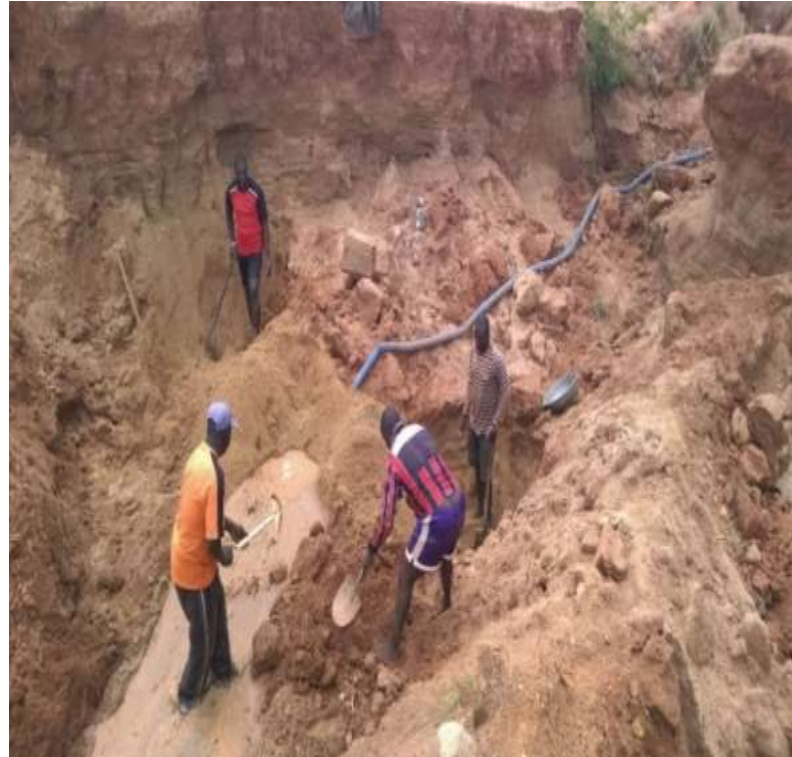
Plate II: Searching for Tin and Columbite at the 'Rayfield' Resort Centre Site (03/06/2015)

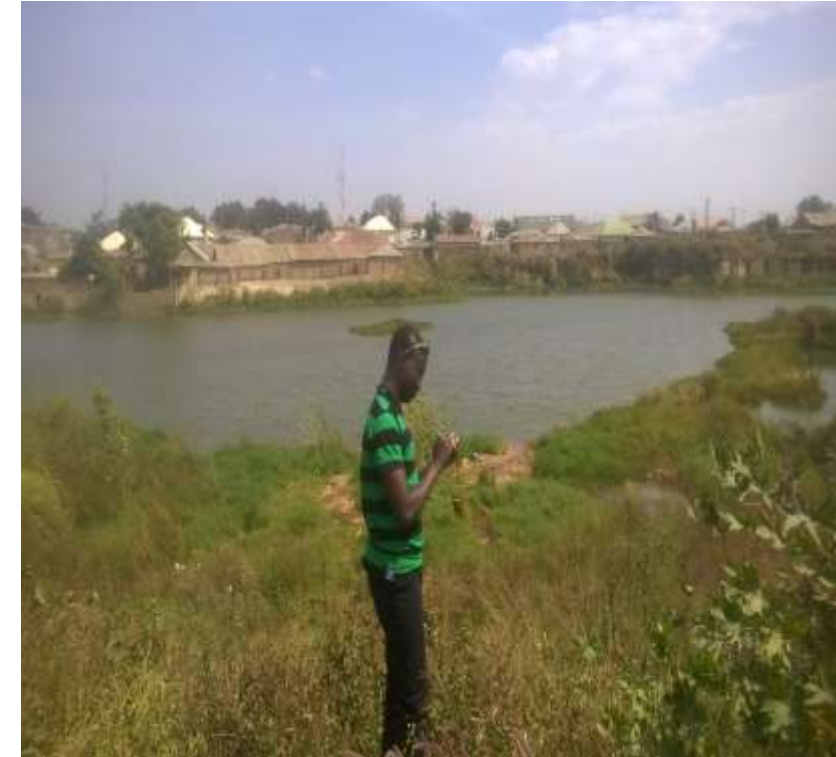
Plate III: Settlements built at the extreme edge of pond (10/11/2015)

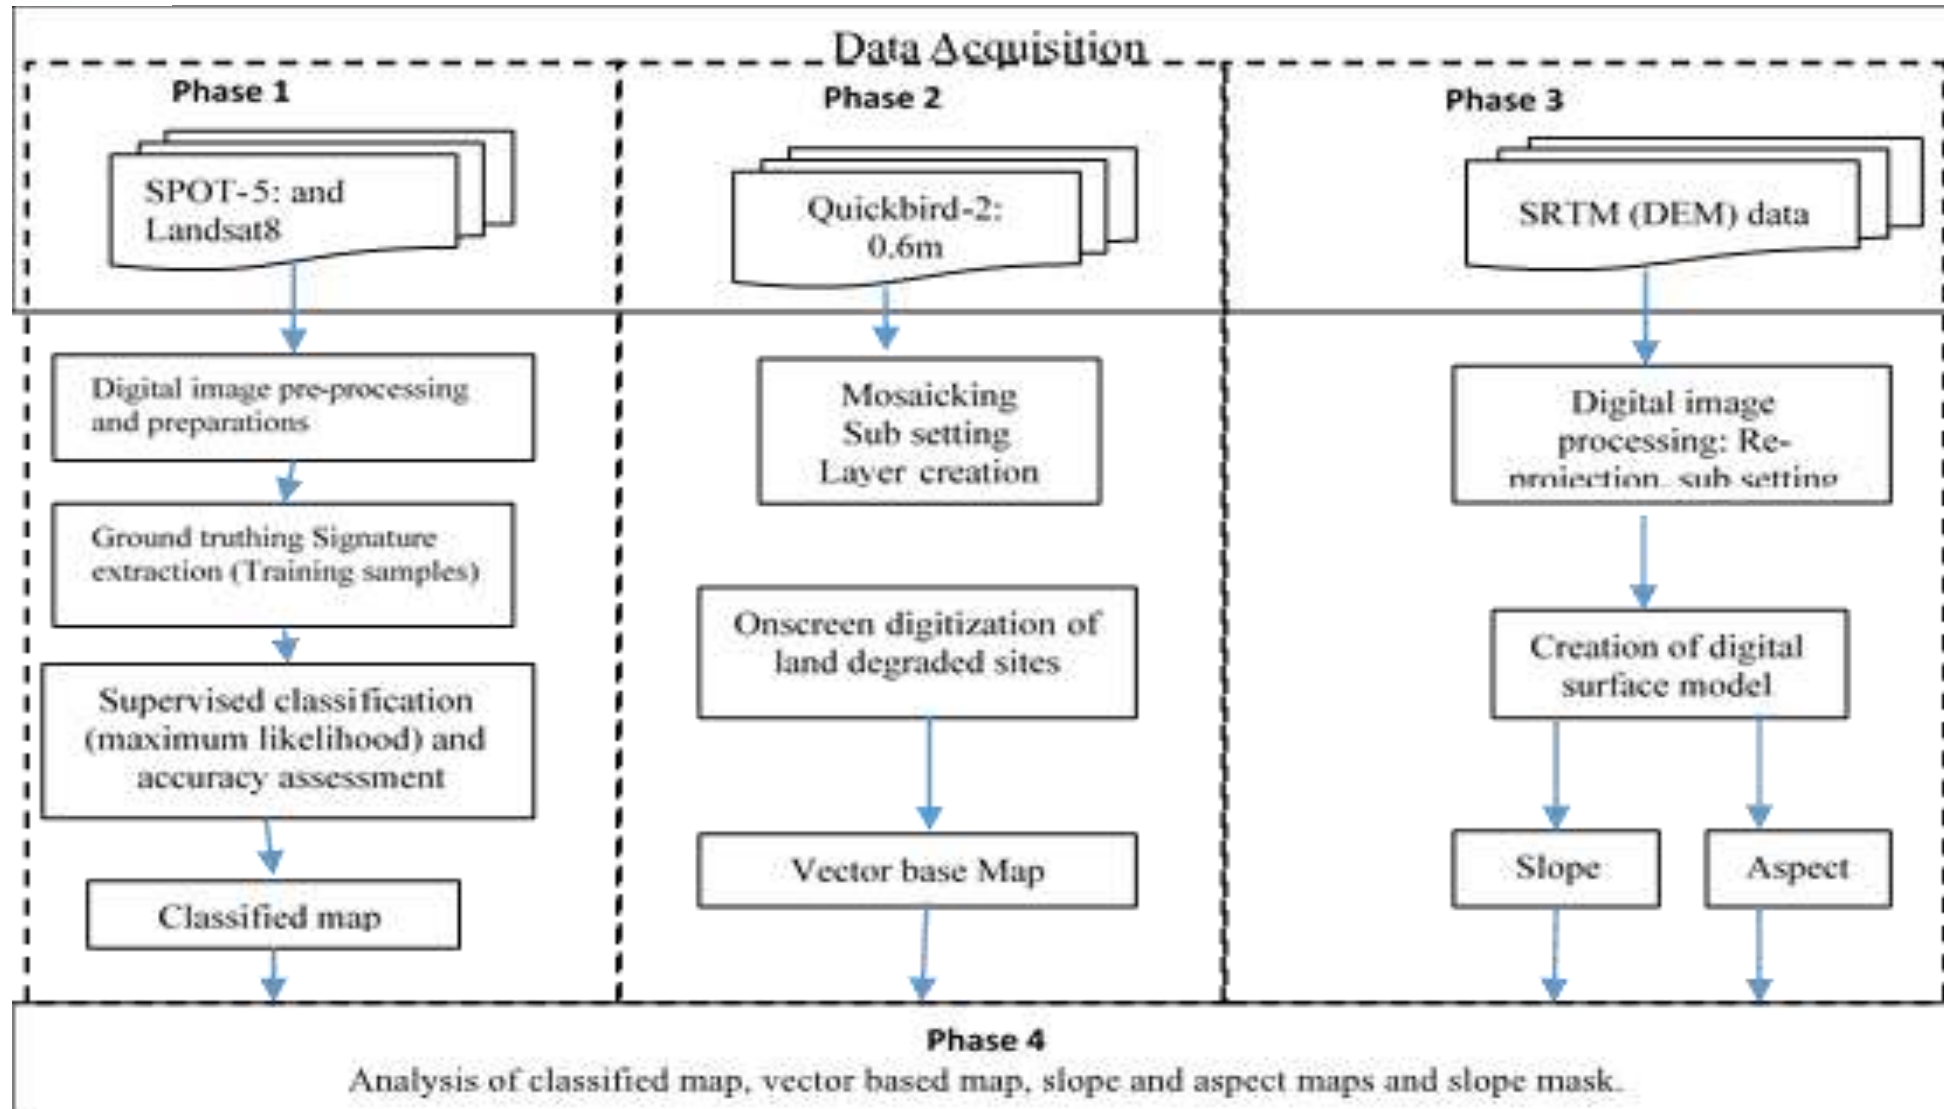
Figure 2: Methodology workflow diagram (after; Bala, 2018)
